TS-PIC-9809925S/9909925S
December 1998

AERIAL PHOTOGRAPHIC ANALYSIS WASTE DISPOSAL, INC., SITE Santa Fe Springs, California Report 1 - Hazardous Waste Site Characterization, Main Site

D. R. Williams
Environmental Services Division
Lockheed Environmental Systems & Technologies Co.
Las Vegas, Nevada 89119

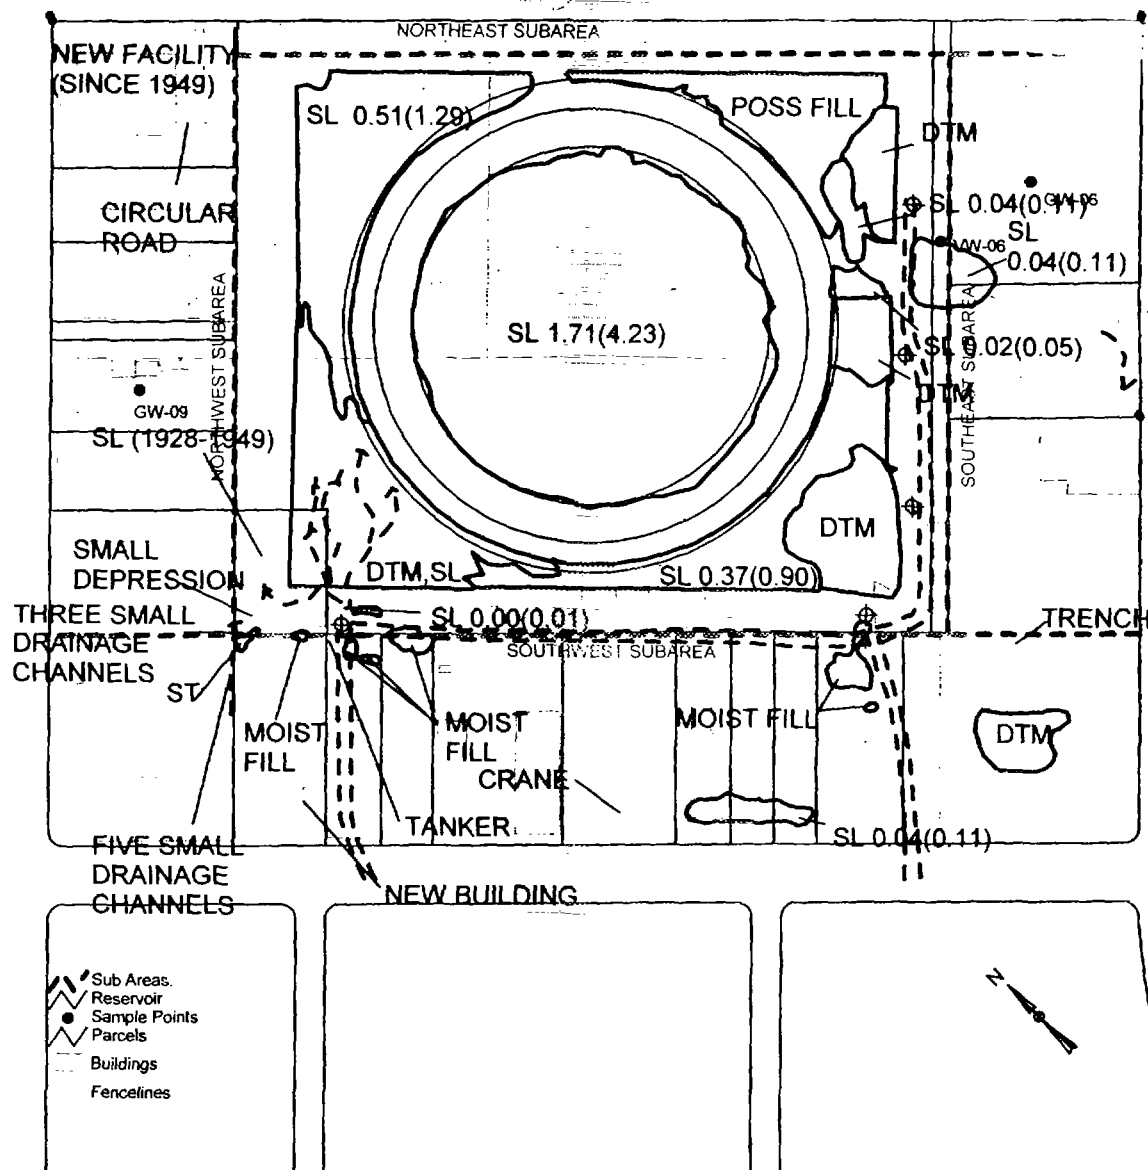
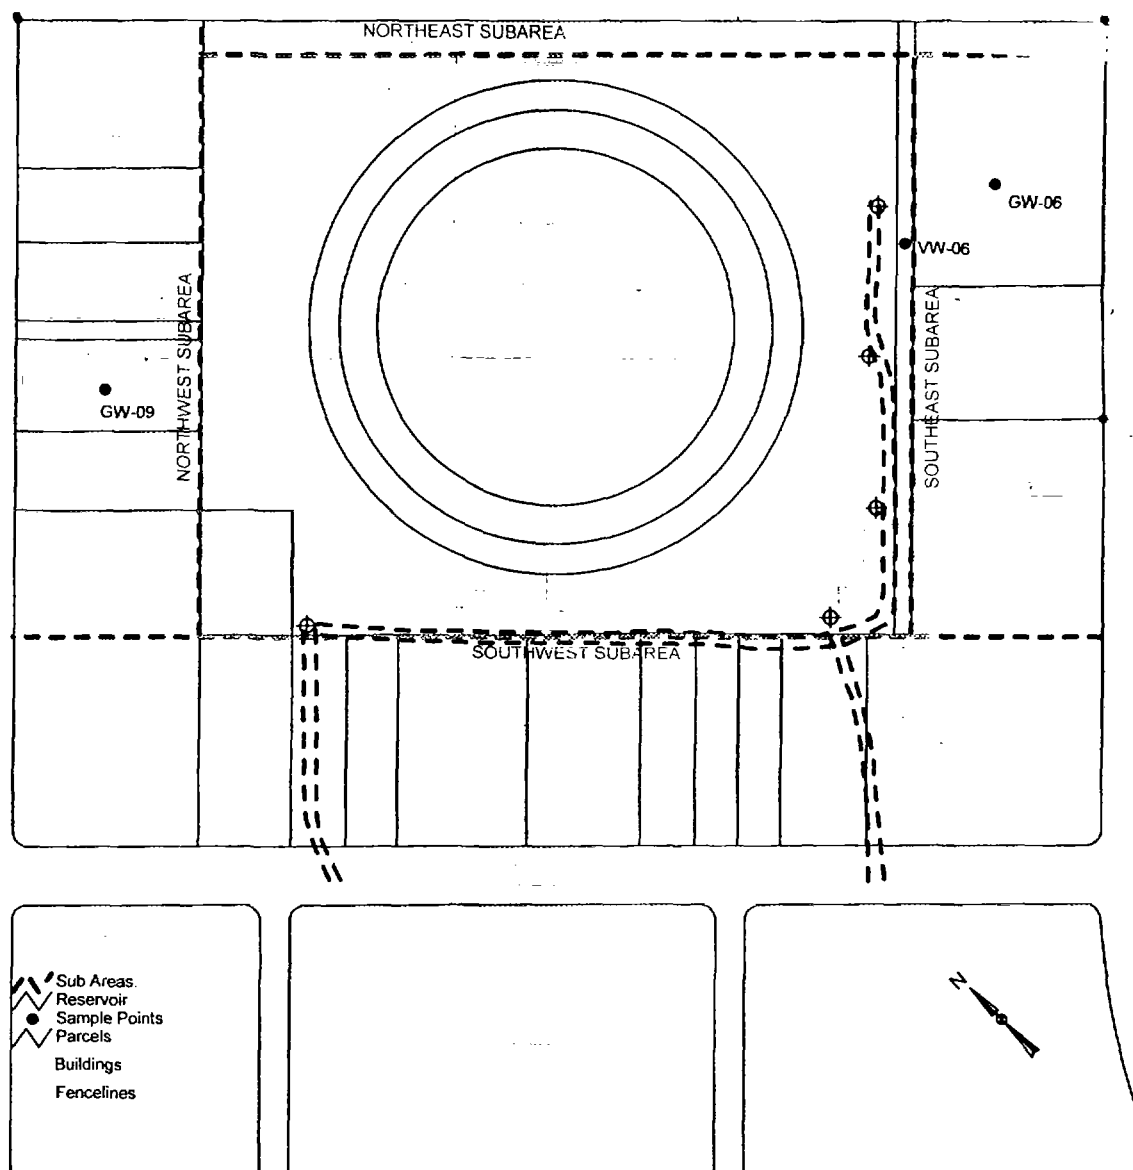
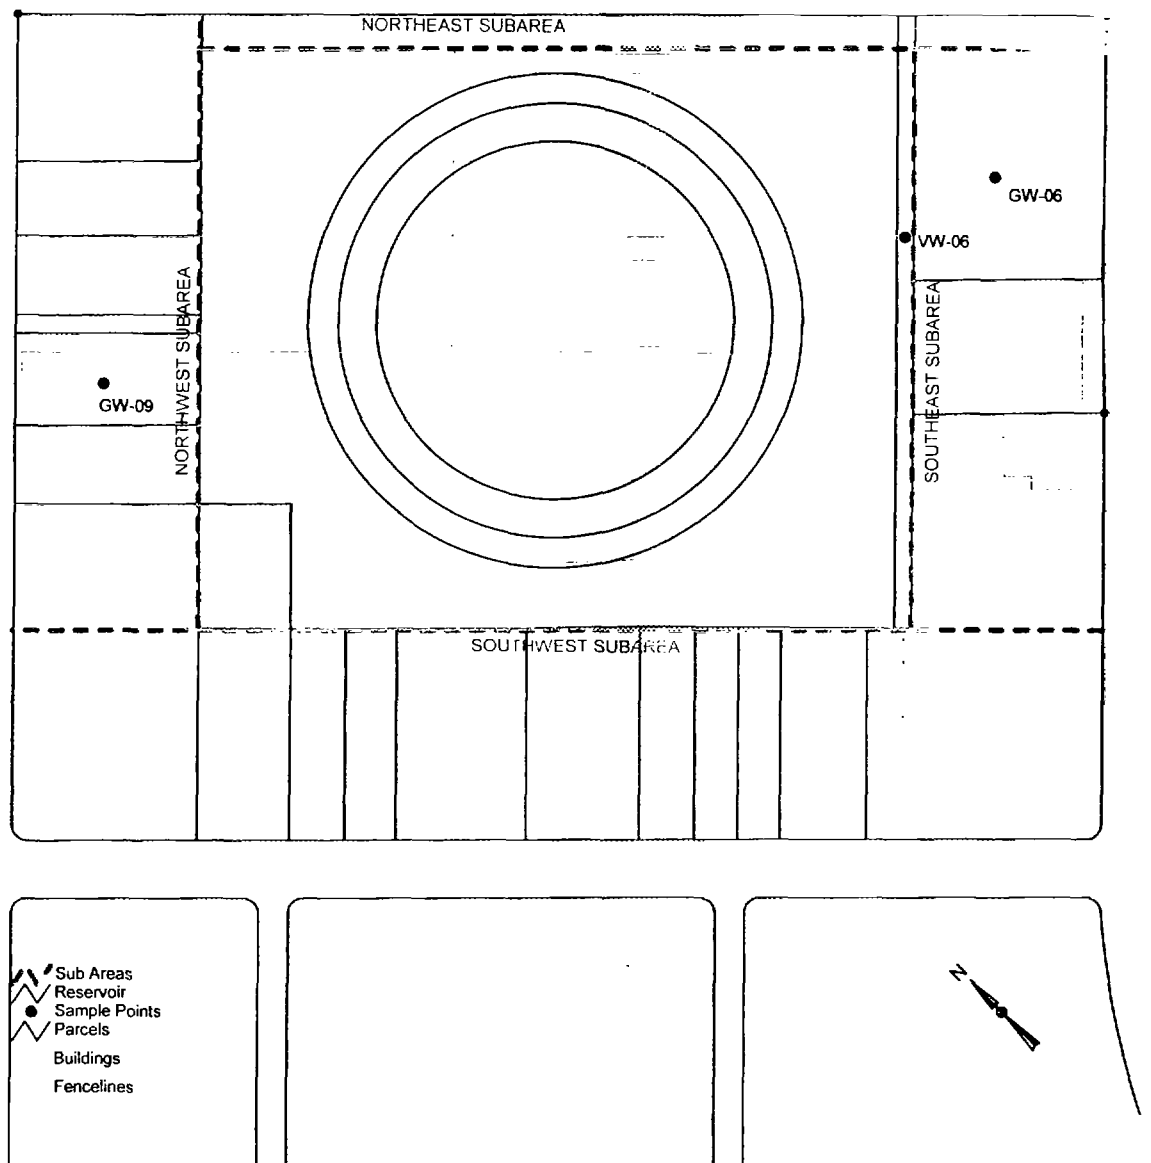
Figure 8. Waste Disposal, Inc., site map, February 25, 1951. Approximate scale 1:3,850.

Little change is seen in Impoundment 1 since 1949, but Impoundment 2 has been partially filled. A small berm (new since 1949 - not annotated) is present southeast of standing liquid present in Impoundment 2. It appears that the berm was constructed to impede the flow of liquid materials from Impoundment 2. A small trench is seen in the old Impoundment 4. Quonset huts (not annotated) are observed in the southern corner of the site; dark-toned material is present nearby.

Moist fill (possible spillage) is noted near two waste disposal points at the southern and western corners of the Earthen-Diked Subarea. Standing liquid is seen near Los Nietos Road. Two small drainageways and an area of standing liquid are noted near the western corner of the Earthen-Diked Subarea. One drainageway leads to the northwest (see discussion under the Northwest Subarea heading); the other drainageway flows southeast to a small area of standing liquid. A tanker truck is present along the access road leading to the waste disposal point at this location. On the July 27, 1951, photograph (Figure 21) a tanker truck is backed up to this waste disposal point and dark-toned liquid is seen next to the tanker. This suggests that the tanker is discharging liquid material into the Earthen-Diked Subarea.

In the northern portion of Land Parcel 3* (located at the western corner of the Earthen-Diked Subarea), are five short, parallel drainage channels leading to a small drainage ditch that flows onto the northeast. Dark stains are seen within these channels. Three additional small channels leading to the northeast are also noted at this corner of Parcel 3. Apparently liquid wastes have been released at these locations and have flowed to the northeast. A small depression exists near the corner of this parcel where these wastes have probably collected. The extreme western corner of the site is not covered by the February 25, 1951, photographs.

A small drainageway that begins at the waste disposal point at the western corner of the Earthen-Diked Subarea flows into an area adjacent to the Earthen-Diked Subarea where standing liquid has been observed in past photographs (1928-1949). In the northern corner of the site (Land Parcel 7*) is a new facility constructed since 1949. A circular road is noted on the southwest side of the facility.

The road network at the site has changed since 1945. New roads are visible along the southeast and southwest sides of the Earthen-Diked Subarea. Five waste disposal points are observed along these roads. The site is accessed from Los Nietos Road.

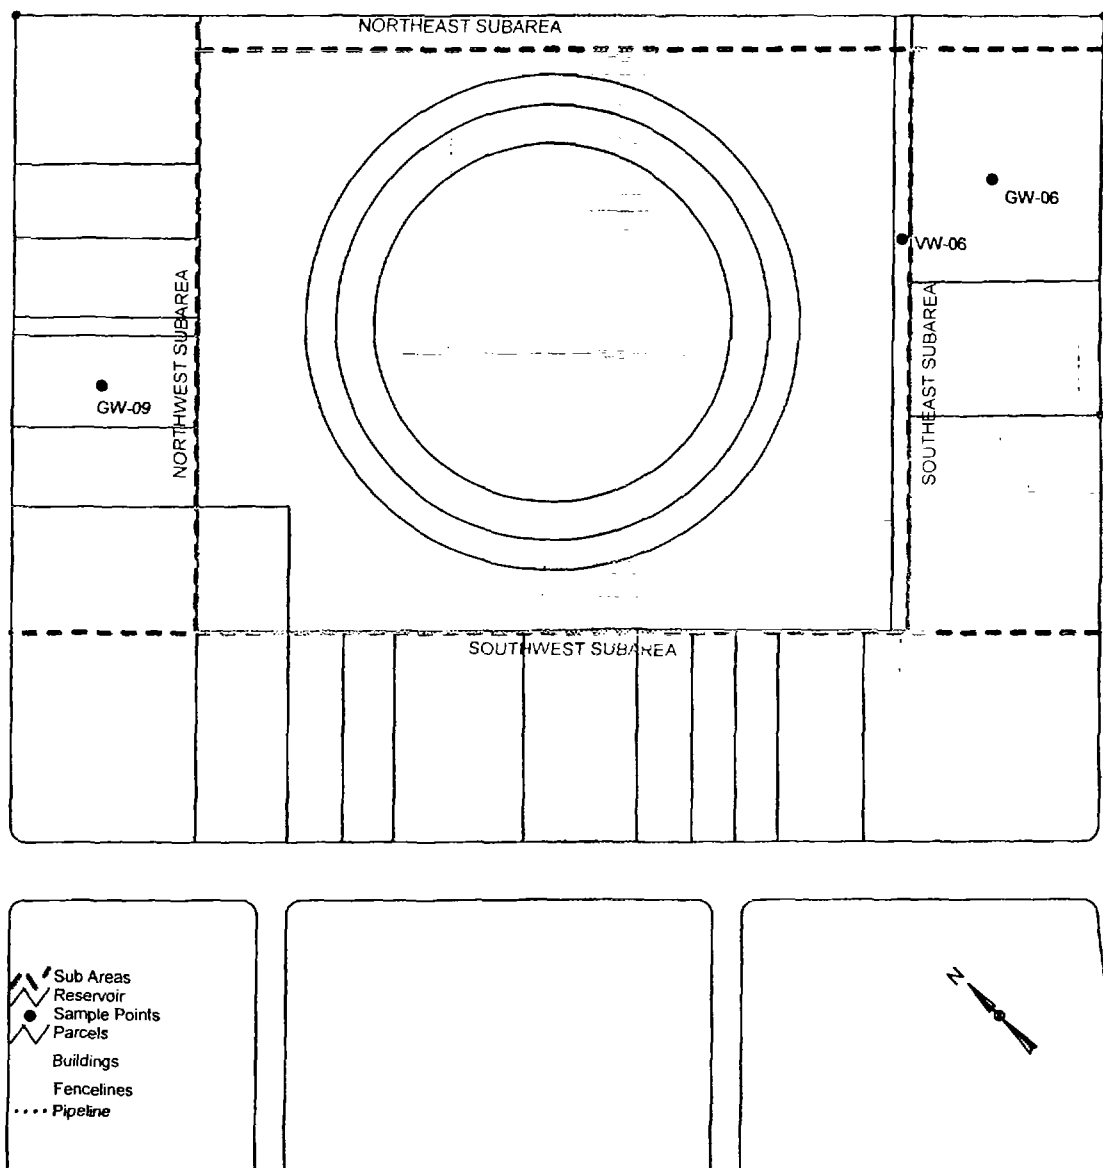
Figure 9. Waste Disposal, Inc., site map, August 9, 1955. Approximate scale 1:3,850.

Standing liquid is present within the reservoir. Dark- and light-toned solid waste material is also present. The reservoir berm is breached in three places and solid and liquid wastes are being placed in the reservoir. Dark-toned material and rubble are noted at the breached berm on the northwest side of the reservoir. Less standing liquid is present within the diked area compared to 1951; instead, almost the entire diked area is occupied by light- and dark-toned material.

The old impoundments seen in 1951 are no longer present. A large deposit of fill and solid waste is present in the eastern corner of the site. A number of Quonset huts and other buildings (not annotated) are observed in the southern corner of the Southeast Subarea. Fill, solid waste, and stains are noted near some of the huts and buildings.

Five new vertical tanks with staining are observed near the southern corner of the diked subarea. Stains are seen on the nearby access road and northwest of the tanks. A small pipeline is observed between the vertical tanks and a small facility to the southwest. Adjacent to this facility is a large graded area and a large stain. This is a landfarming operation. To the north, a wellhead pumping station is present. To the northeast three drum storage areas, two large vertical storage tanks, and standing liquid are present. A probable truck tanker transport company is located in Parcel 3. A

large stain is seen in the facility lot and standing liquid is located in the northern corner of the parcel as observed in 1951. Dark stains are present within a small drainageway (not annotated) that leads northeast to a small depression containing standing liquid.

Since 1951 fill and light- and dark-toned material have been deposited next to the Earthen-Diked Subarea. Southwest of Parcel 7 (northern corner) a large area of fill has been spread on the surface of the ground; a large possible stain is present at the edge of the filled area.

New roads (since 1951) have been constructed around the reservoir and in the Northwestern Subarea and new disposal points are associated with these roads.

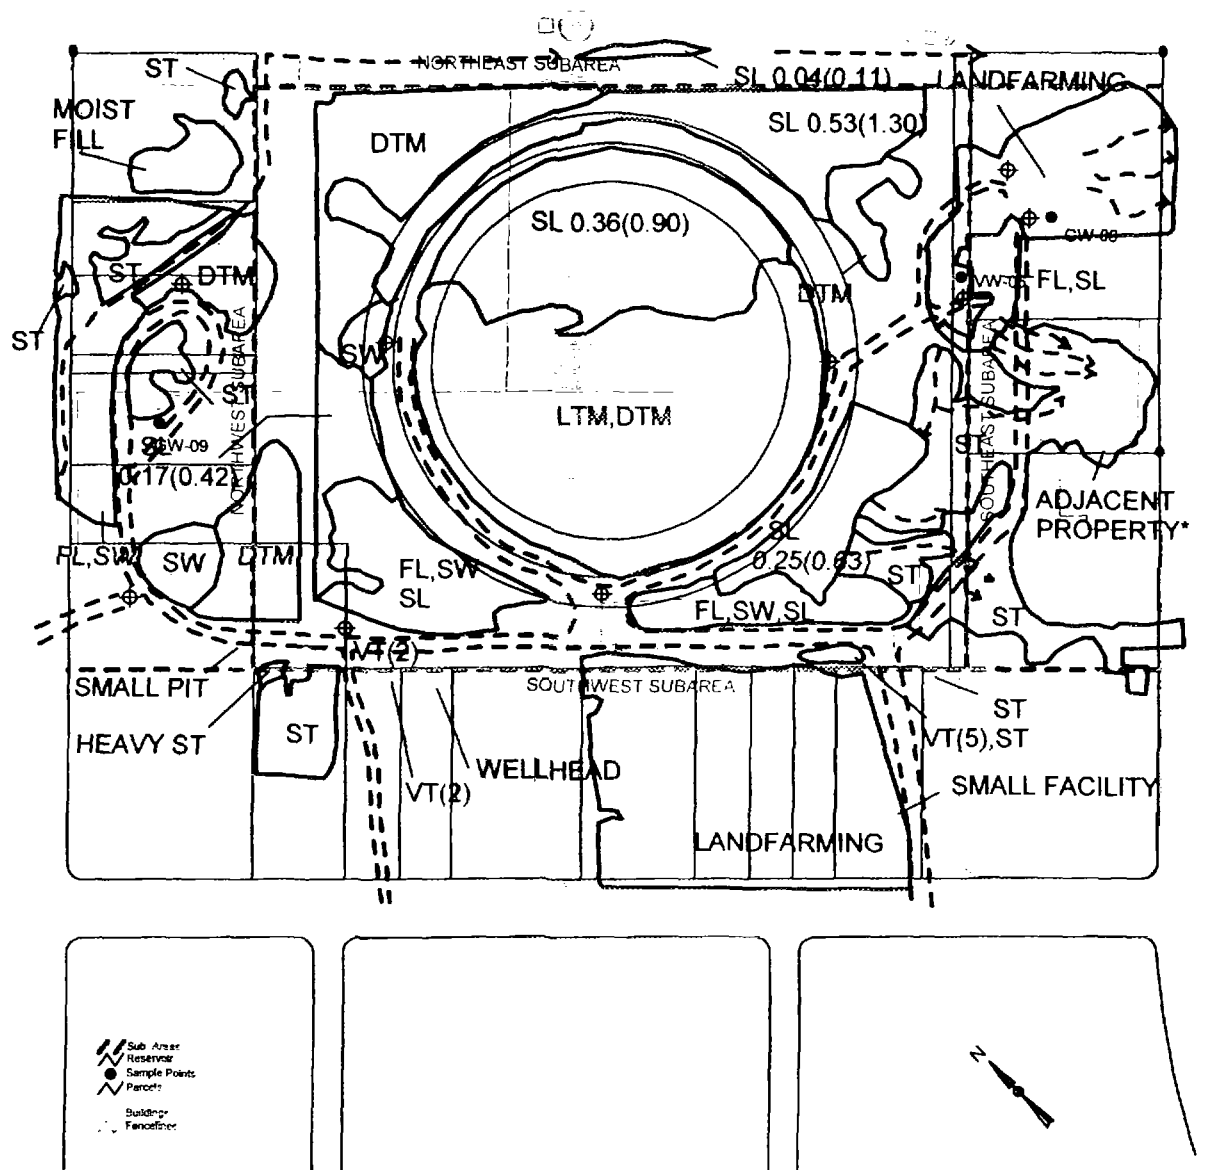
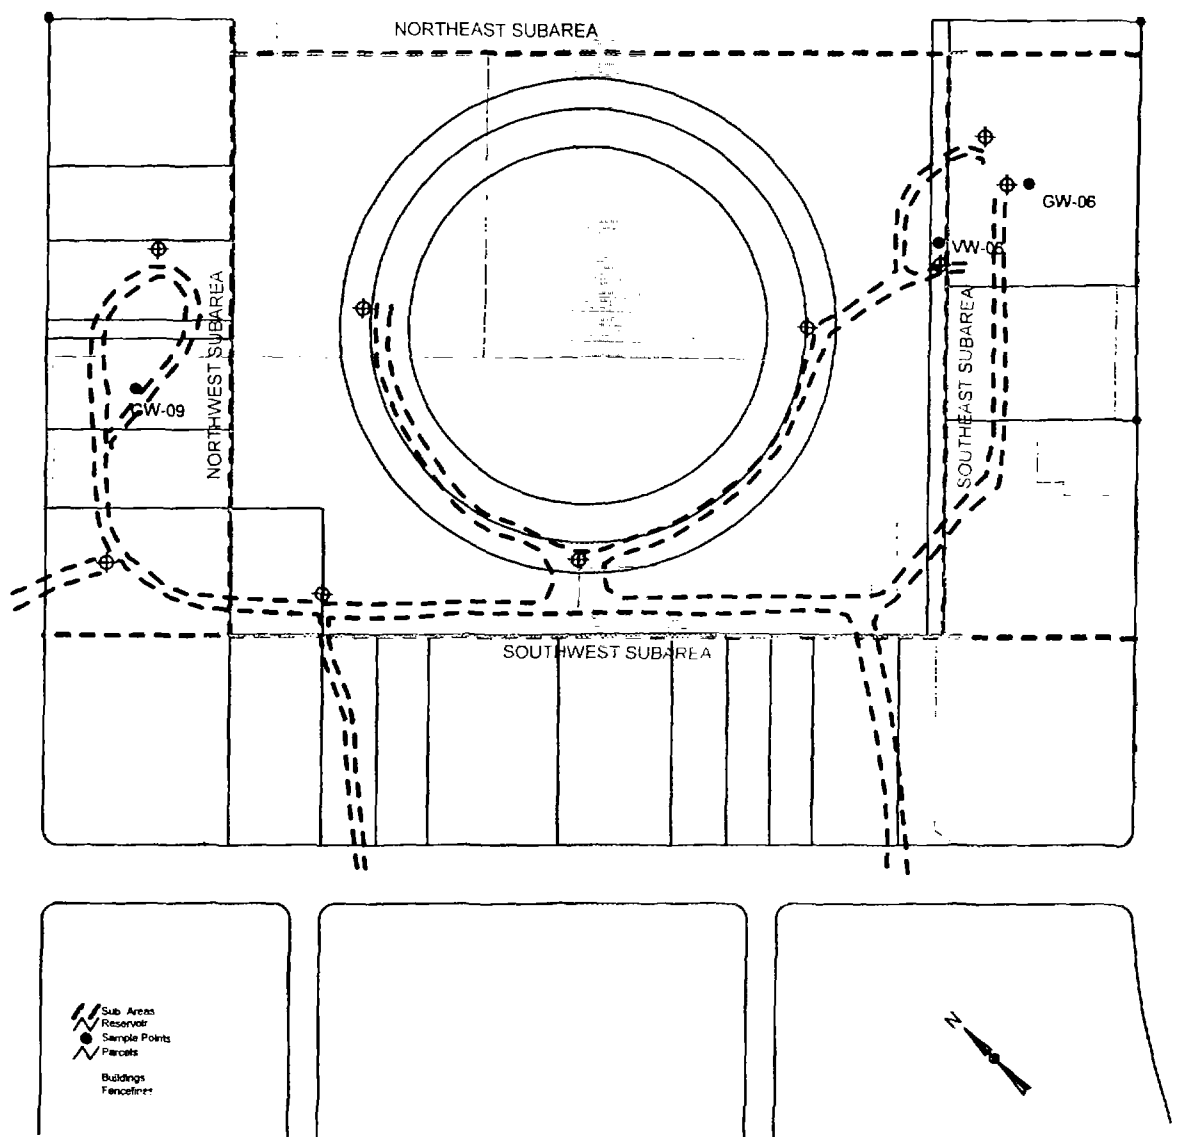
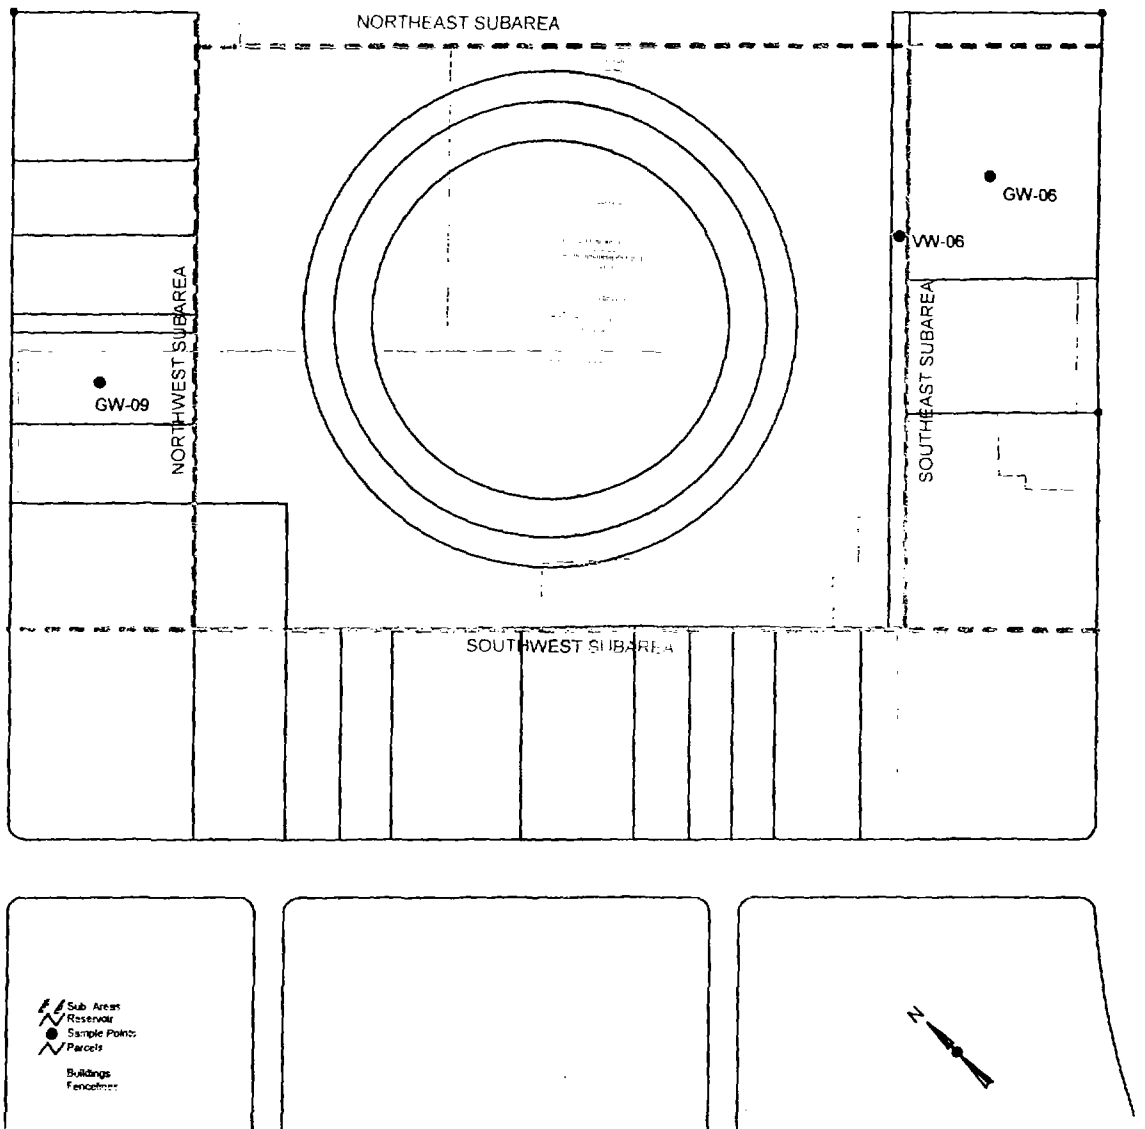
Figure 10. Waste Disposal, Inc., site map, January 17, 1956. Approximate scale 1:3,850.

Since 1955, additional landfarming is present in the eastern corner of the site. Drainageways and associated staining are evident along the southeastern side of the diked area. Increased disposal activity is evident in the Northwestern Subarea.

It appears that the level of liquid in the reservoir has increased when compared with the level observed in 1955. Light- and dark-toned material continue to be present in the reservoir. The areal extent of visible liquid within the earthen dike has increased since 1955.

The large area of mounded fill and solid waste seen in the eastern corner of the site in 1955 has been graded and liquid waste spread on the surface of the filled area. A portion of the liquid waste has flowed to the southeast into a drainage ditch next to Greenleaf Avenue. To the southwest, additional landfarming is observed. Liquid waste has flowed to the southeast across an access road and into the Adjacent Property* where widespread staining is noted. Staining observed south of the large area of standing liquid may be due, in part, to the pumping of liquids through "gopher holes" (EPA 1998) in the reservoir berm. Staining extends to Greenleaf Avenue. Staining (not annotated) is also present on other roadways within the Southeast Subarea.

The landfarming seen next to Los Nietos Road in 1955 continues to be present. Stains are visible adjacent to the five vertical tanks seen in 1955. To the northwest the facility lot at Parcel 3 (western corner of site) is uniformly stained while a darker stain is evident at the northern corner of

Additional roads have been constructed in the Southeast and Northwest Subareas of the site. Two new waste disposal points are also present.

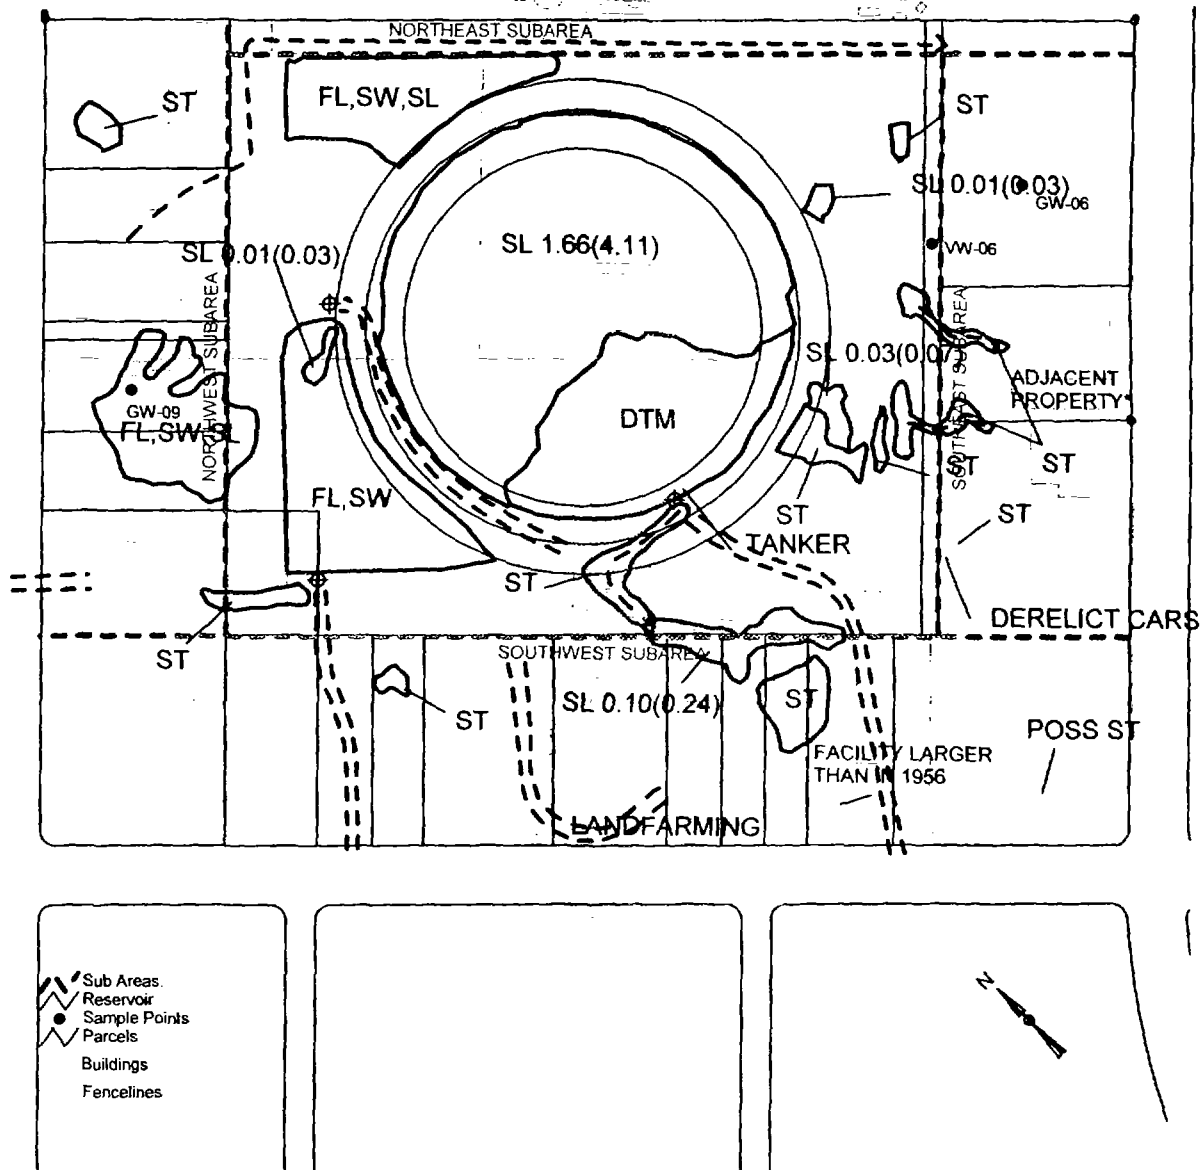
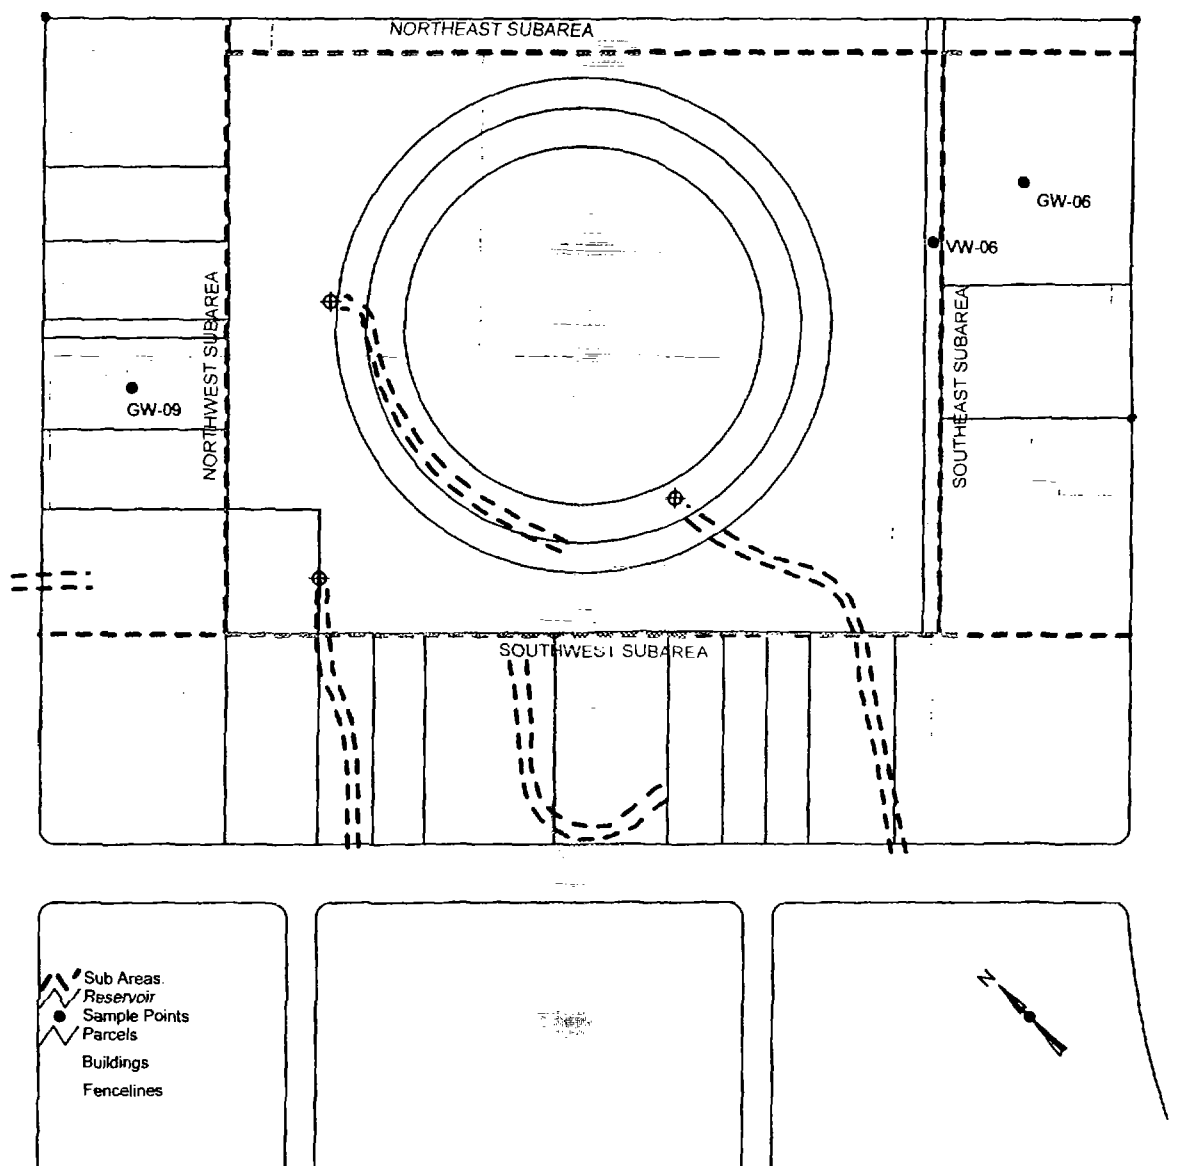
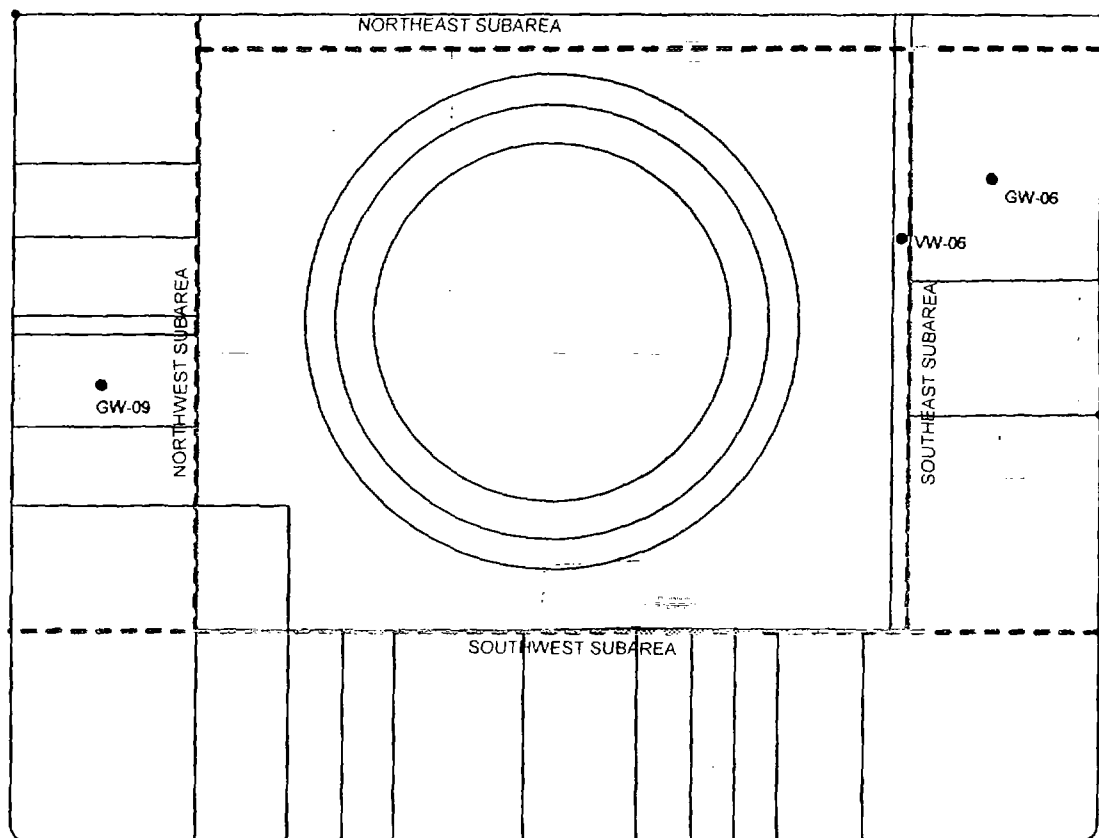
Figure 11. Waste Disposal, Inc., site map, January 17, 1958. Approximate scale 1:3,850.

The road around the southeast side of the reservoir and the road in the Northeast Subarea are no longer in use.

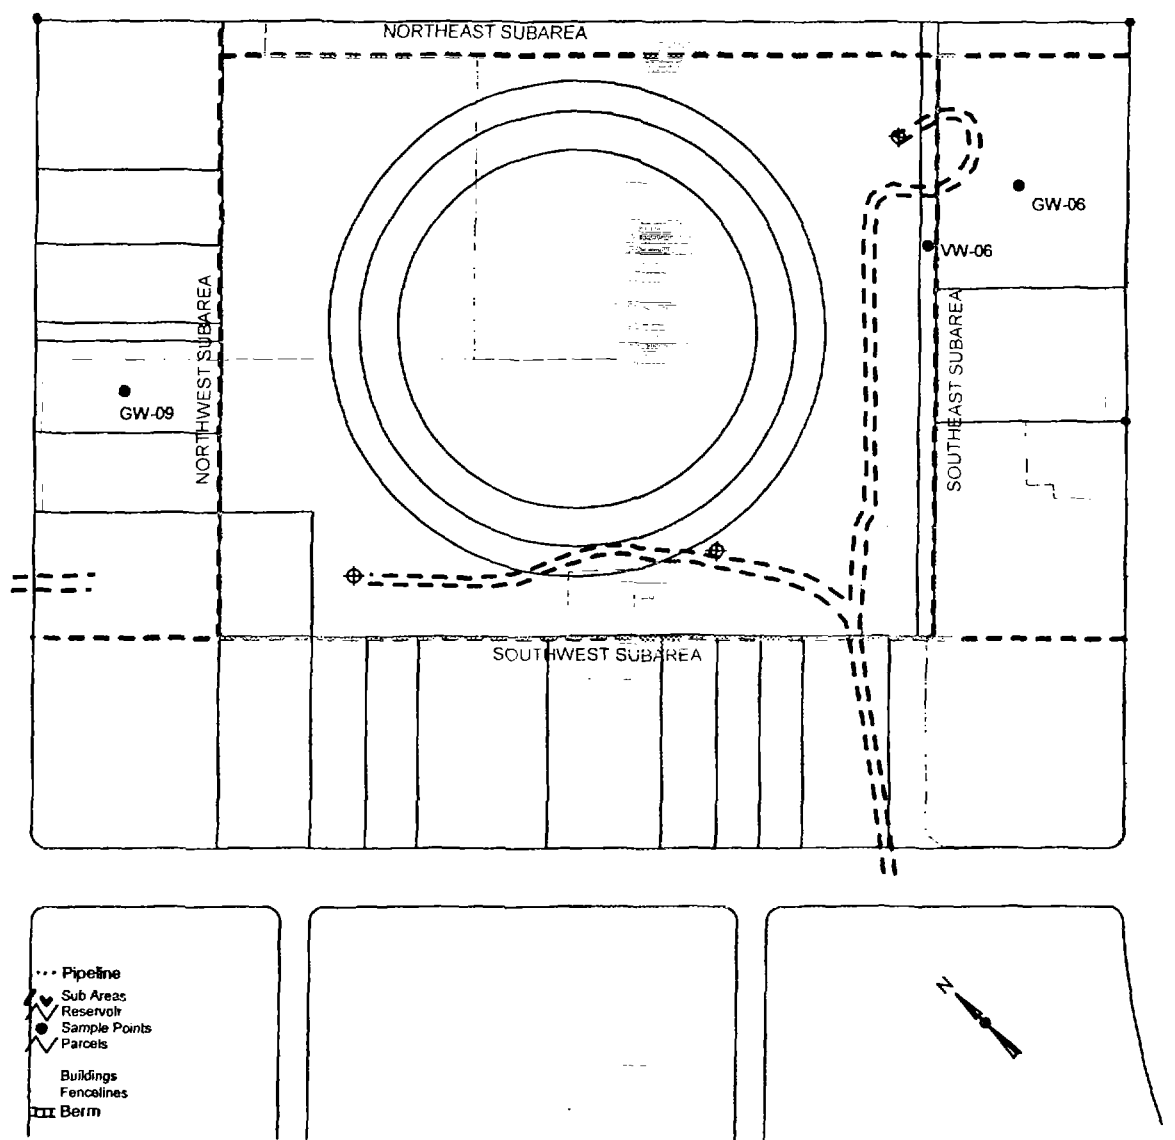
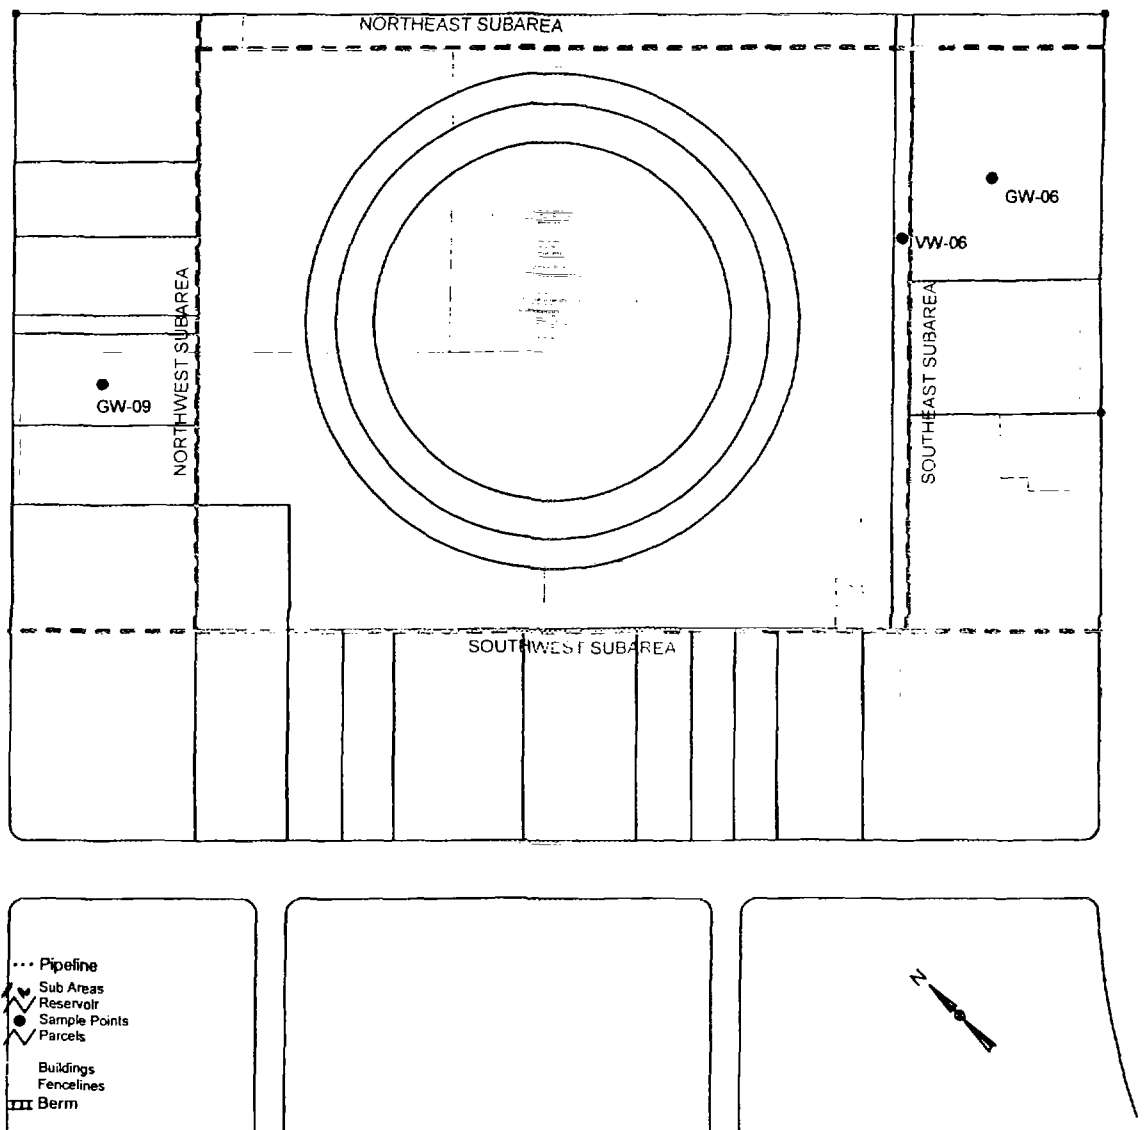
Figure 12. Waste Disposal, Inc., site map, June 15, 1959. Approximate scale 1:3,850.

Since 1958 a new road has been constructed on the southeast side of the Earthen-Diked Subarea.

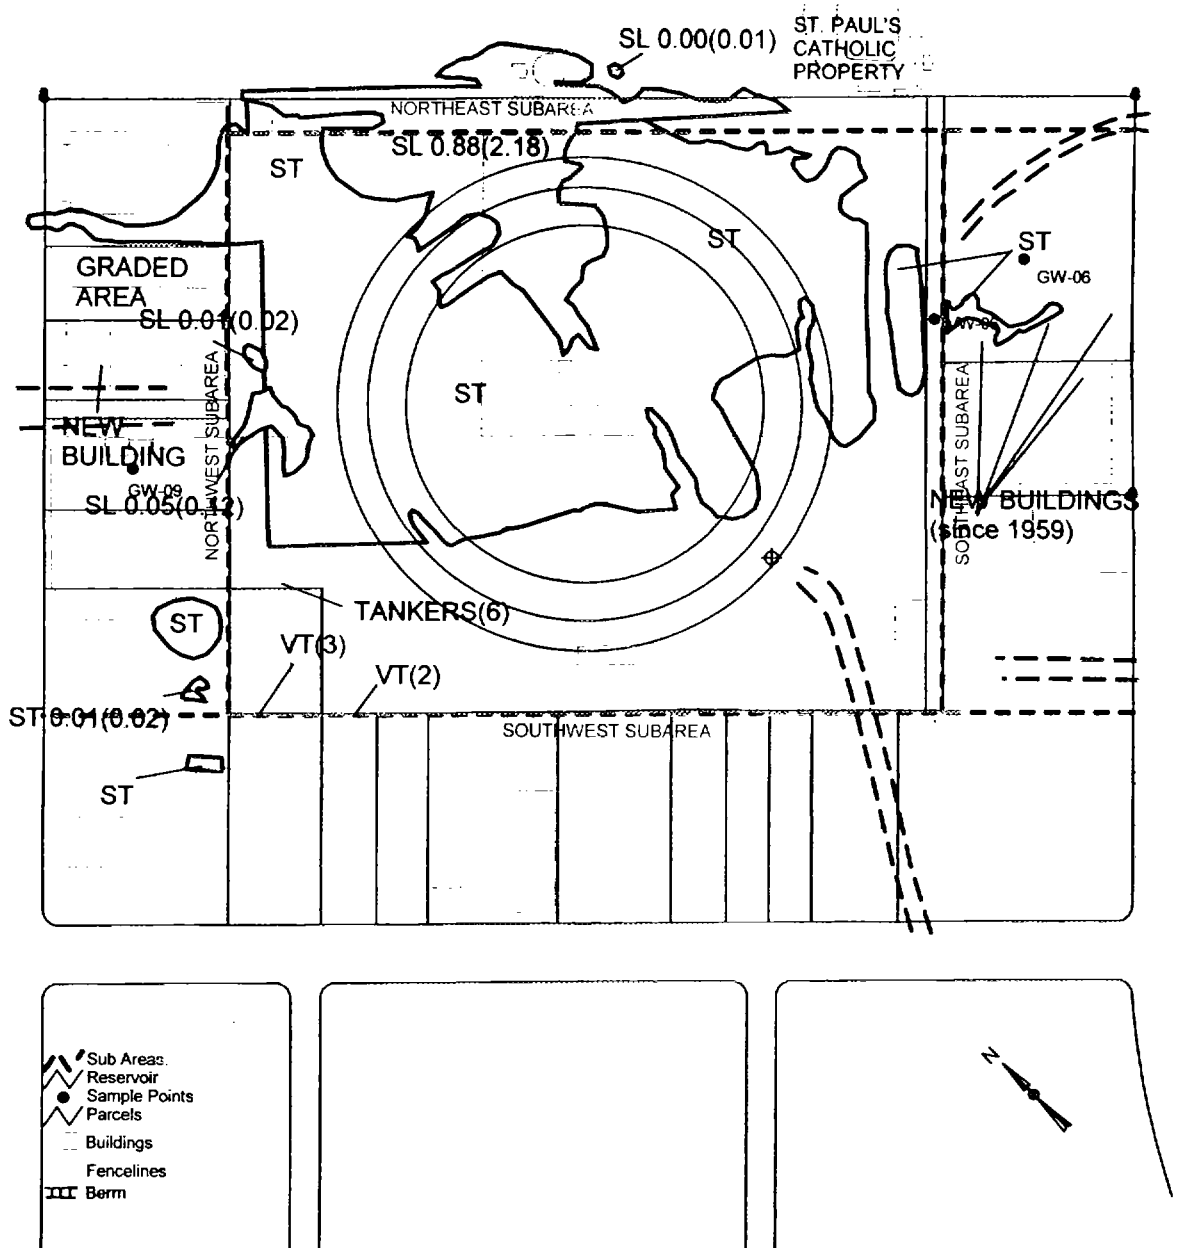
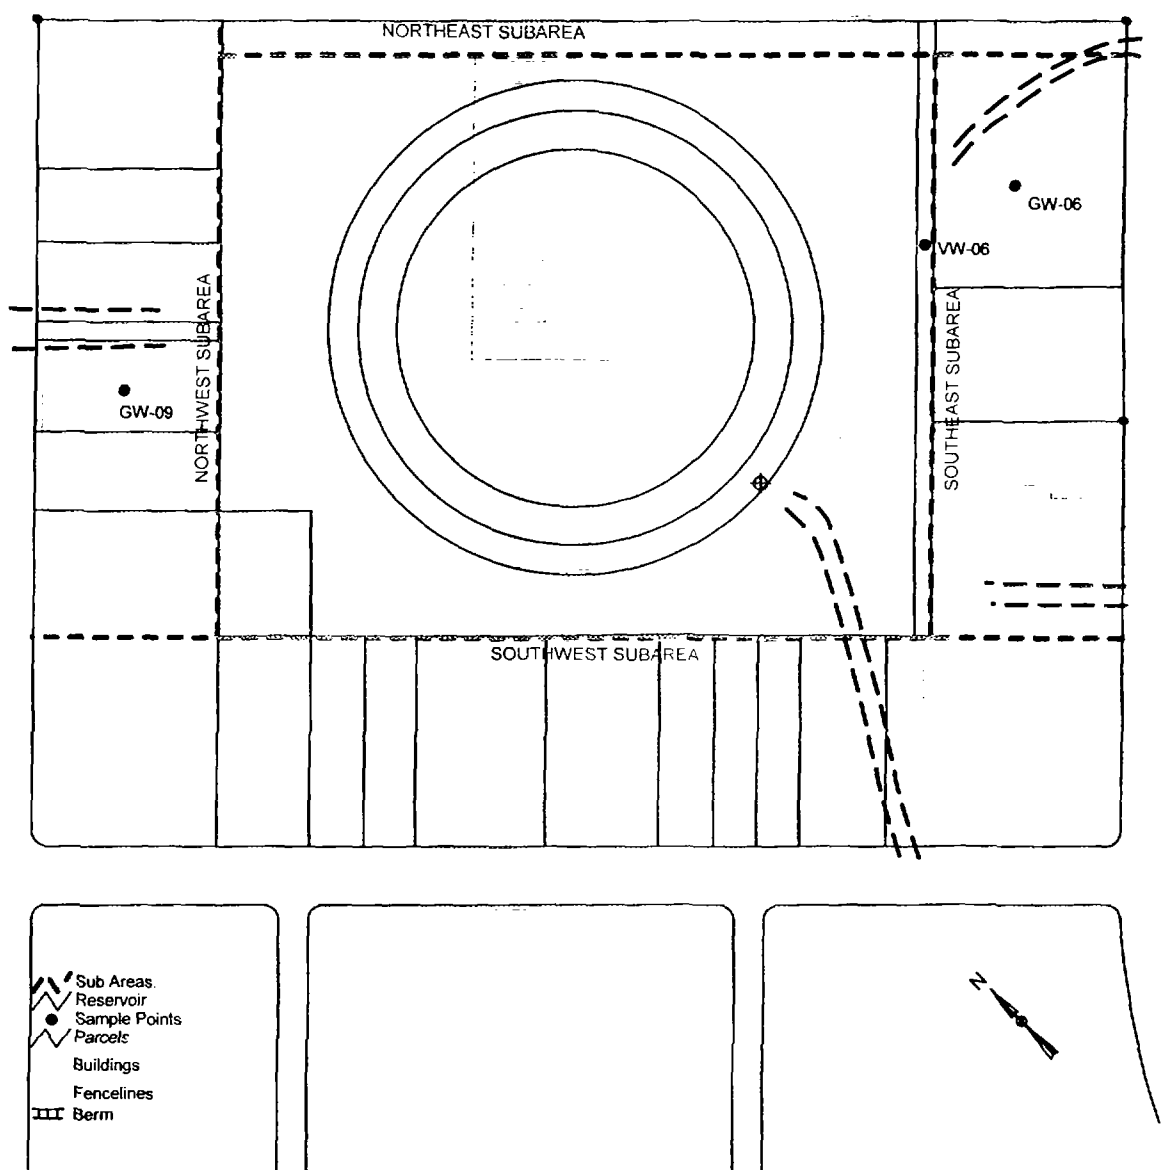
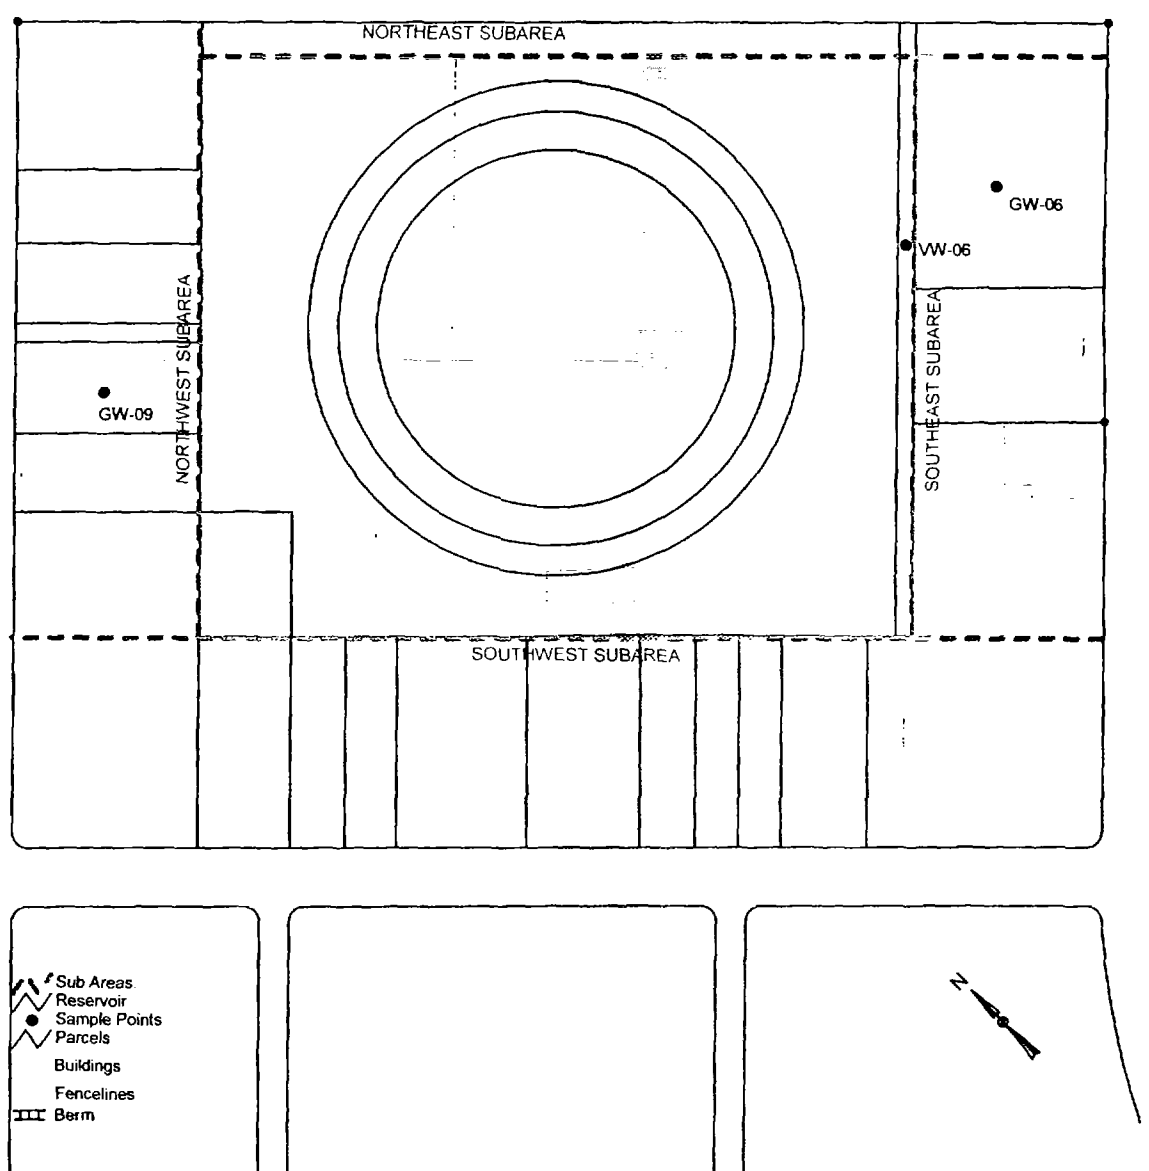
Figure 13. Waste Disposal, Inc., site map, December 2, 1962. Approximate scale 1:3,850.

The reservoir has been completely filled and a large area of staining and standing liquid remains.

Because site activity had decreased since 1959, only two roads are seen on the site.
